1: Introduction

1:1 Camber Ecology Limited were asked to conduct a basic walk over survey of land within the grounds of Hadlow Down playing field (postcode TN22 4JE), it is proposed to demolish the existing pavilion and replace with a newer, larger building more fit for purpose.

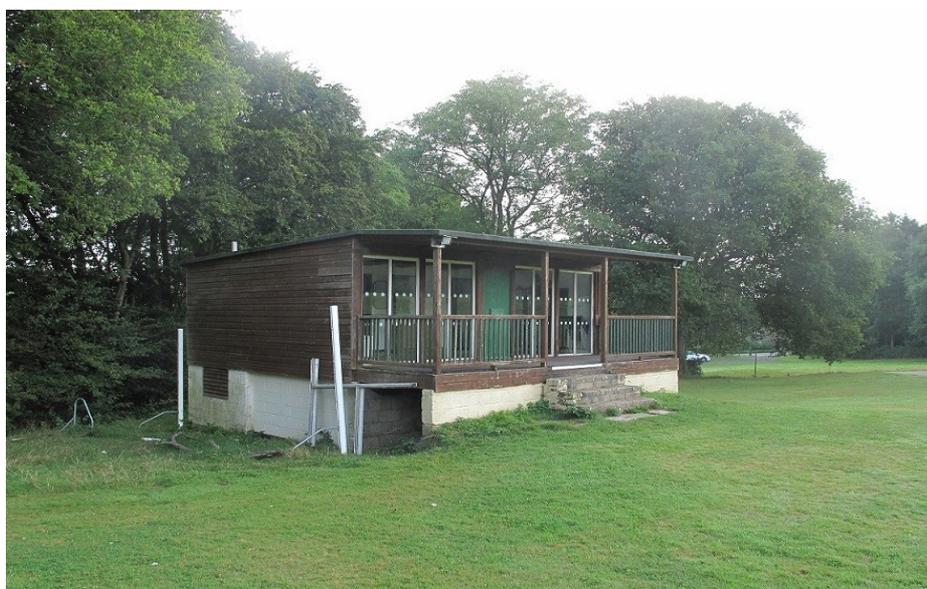
1:2 The site sits immediately east of School Lane and is accessed from that road, the playing field itself consists of several levels and the current pavilion is situated on the slightly elevated ground to the south east of the access gate. The current building is sited on land of low ecological value, but is immediately adjacent to mature native trees (see fig 1 below).

Fig 1 The footprint of development is situated on land of low ecological value, however, note the mature trees immediately adjacent to the building.

5:3 If at all possible the mature Oak tree near the existing pavilion should be left intact. Native Oak is considered one of the best trees for attracting a wide range of insects, which in turn, are important for larger fauna as a food source. There seems no real justification for this trees removal and it is likely to be important to foraging bats as well as a variety of other fauna.

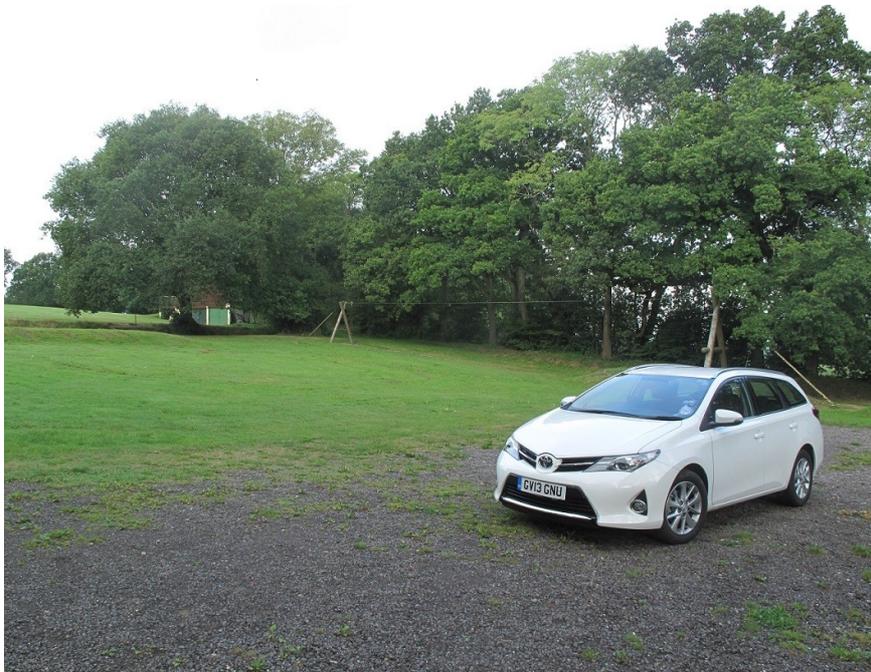
2:1 A small area of semi hard standing is provided just inside the entrance gate for parking (see fig 2 overleaf); typical species here included Knotgrass (*Polygonum arvensis*), Pineapple scented mayweed (*Matricaria matricarioides*), Broad leaved plantain (*Plantago major*), Bent (*Agrostis sp*), Annual meadow grass (*Poa annua*), Daisy (*Bellis perennis*), Dandelion (*Taraxacum sp*) and Clover sp (*Trifolium sp*)

Fig 2 Parking area just inside entrance, just off School Lane, adjacent to the lower level amenity area.

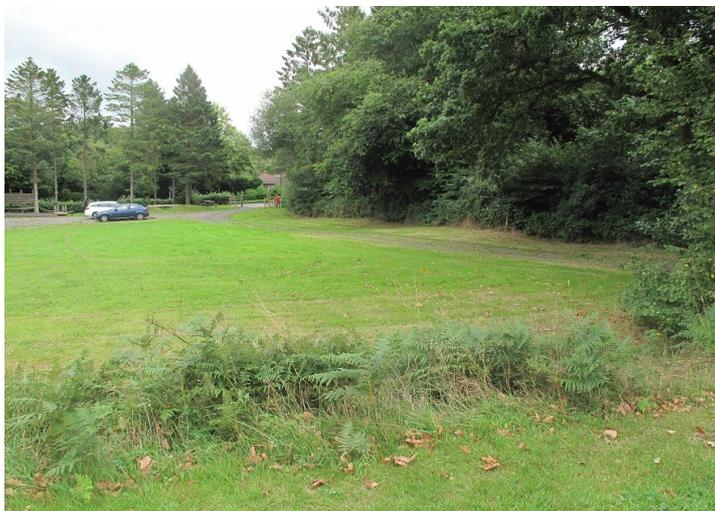
2:3 A grassy bank separates this lower level amenity area from a larger elevated cricket pitch. This grassy bank is less intensely managed and this lighter mowing regime allows Bracken (*Pteridium*) to form dominant stands (see fig 3 overleaf). Stinging nettle (*Urtica dioica*) and Dock sp (*Rumex sp*) were also noted suggesting areas of high nutrient.

Fig 3 A grassy bank effectively demarcates the lower level amenity area from the elevated cricket pitch; view looking west toward entrance and parking area.

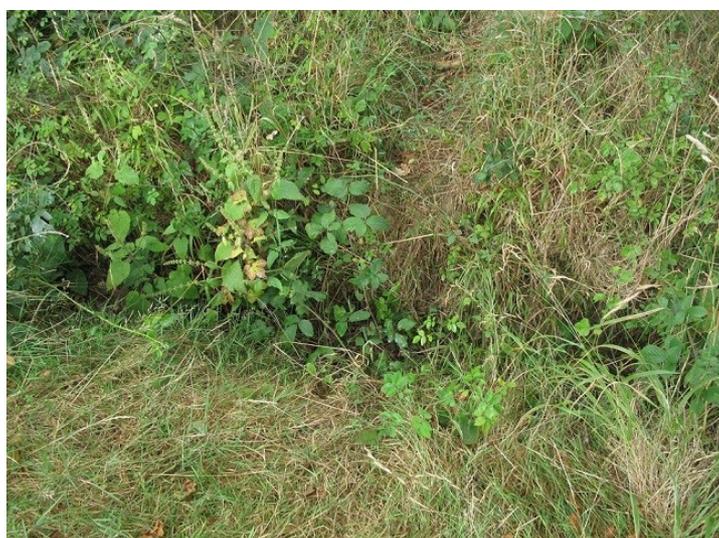
2:5 A dry ditch surrounds much of the playing field (see fig 4 below), this is devoid of water for most of the year; however, species such as fleabane (*Pulicaria dysenterica*) and Soft rush (*Juncus effuses*) do suggest some moisture retention. Other species noted here included Tufted hair grass (*Deschampsia caespitosa*), Cocksfoot (*Dactylis glomerata*), Willowherb sp (*Epilobium* sp), Common vetch (*Vicia sativa*) and Wood brome (*Brachypodium sylvatica*).

Fig 4 A dry ditch surrounds much of the site, but holds little, if any water for most of the year.

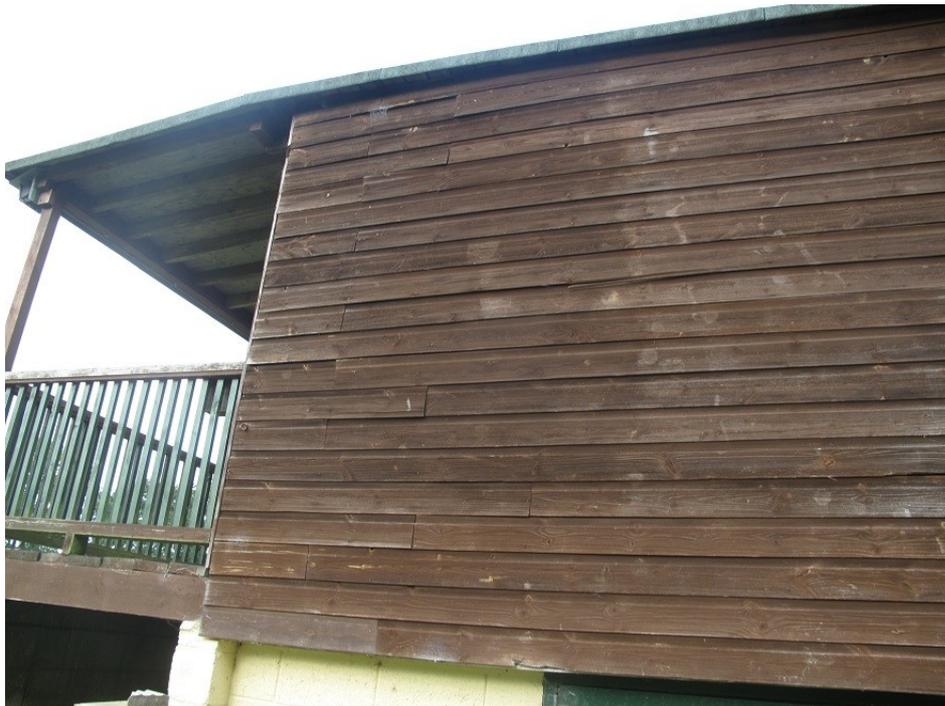
2:7 The structure to be demolished is of partial breeze block construction supporting a timber frame. There is a flat timber roof with a covering of roofing felt direct to the timber. The timber frame is covered with timber cladding as shown below (Fig 5). The original structure was built in 1975 with an open timber balcony added later.

Fig 5 Note the timber frame sitting on breeze blocks with timber cladding.

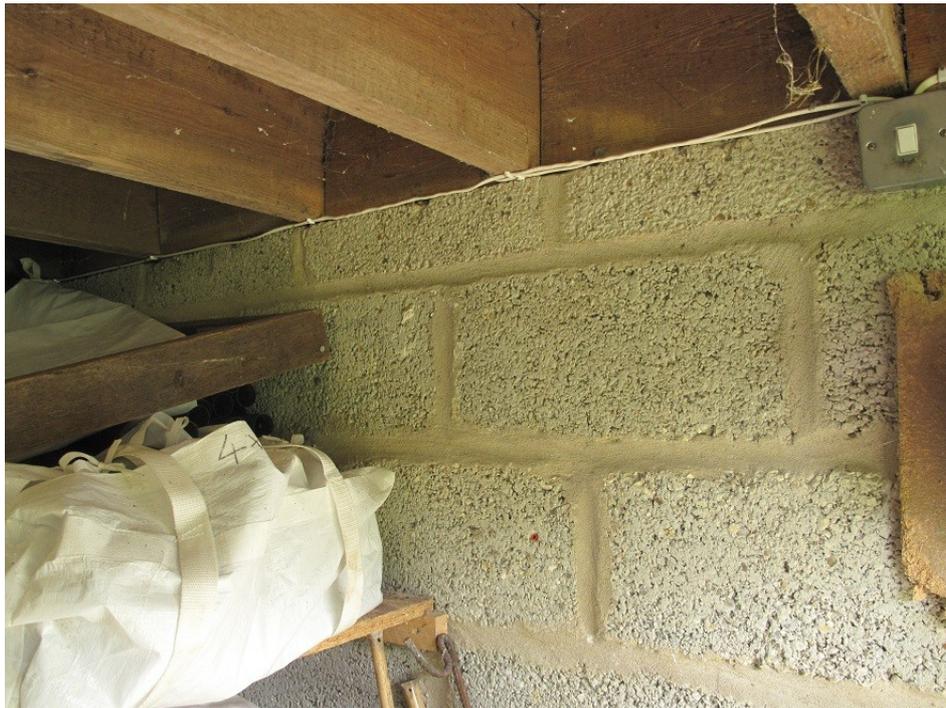
There are several under story areas, one of which was not accessible on the day of the survey (see fig 6 overleaf)

Fig 6 Understory area.

2:8 Whilst on site the structure was inspected internally and externally for bats, or signs of occupancy by bats, with the exception of one under storey area which was not accessible.

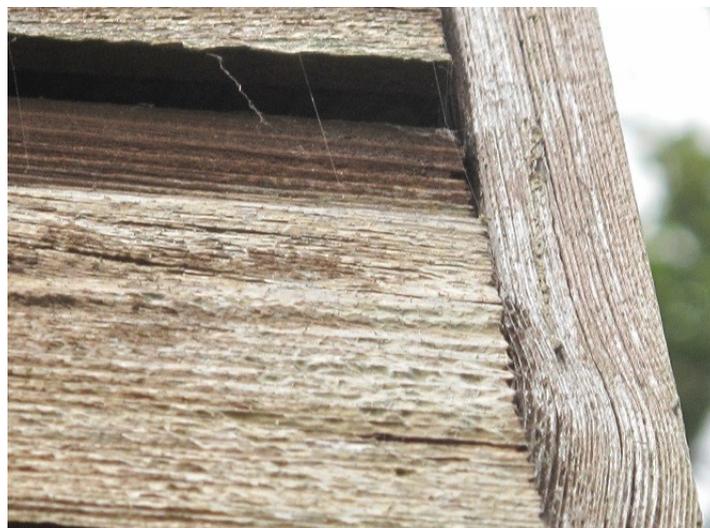
2:10 An inspection of the structure showed limited potential for purchase or concealment by crevice dwelling bats. These included gaps under wooden cladding and crevices between pieces of timber (see figures 7 below and 8 overleaf)

Fig 7 Gaps under tiles may provide some opportunity for concealment and purchase.

5:1 Although the potential of the existing building to provide a place of shelter and protection to bats is limited, usage by individual, or small numbers of animals cannot be totally discounted and under current guidelines of good practice, some further survey work is advised; this will take the form of at least one dusk emergence survey and one dawn survey using experience personnel with bat detectors. This is partly based upon the fact that the existing pavilion is placed in close proximity to excellent foraging and commuting habitat for bats. When considering the potential to provide a place of shelter and protection, adjacent habitats need to be taken into account, in this case there is excellent foraging and commuting potential within a few metres of the building.

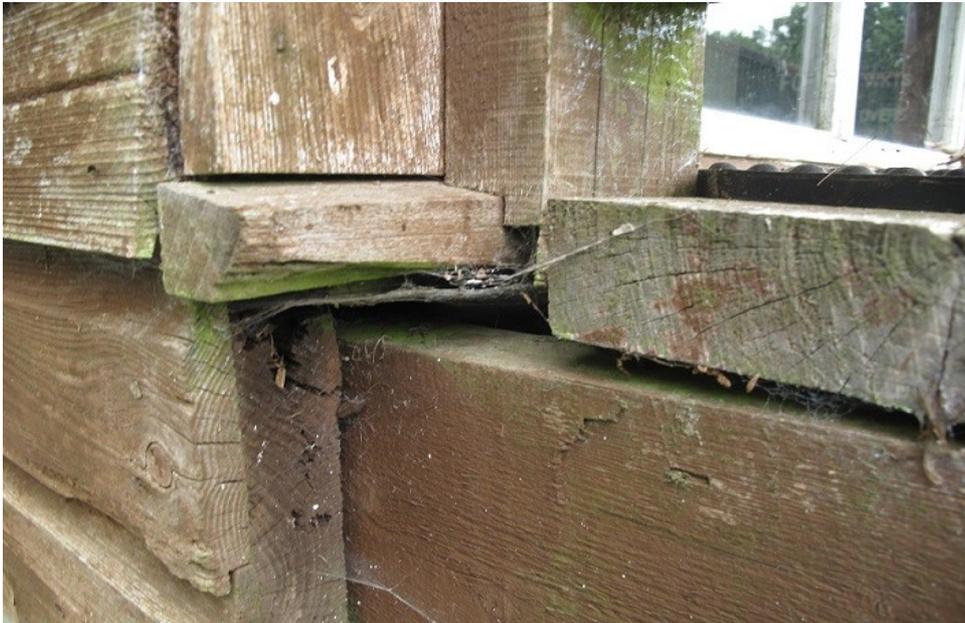
Fig 8 Gaps between timber pieces may provide opportunities for purchase and concealment by bats.

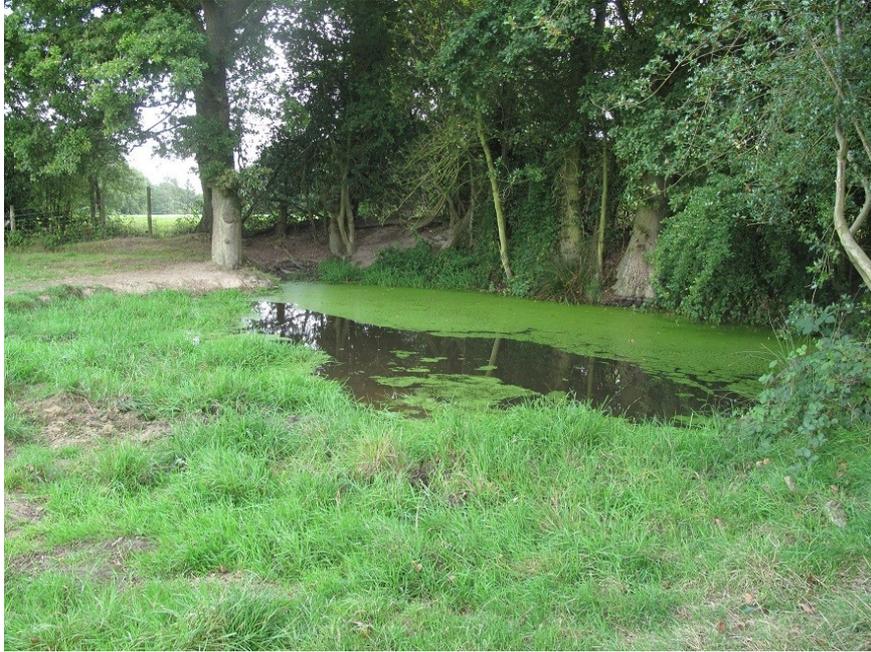
3:3 There are several ponds within a couple of hundred metres of the proposed works and the farmer who owns that land seems to think at least one of those ponds has **Great crested newt** present. These animals can move up to one kilometre away from the breeding ponds and although the immediate area of development is very poor habitat, a dry ditch and mature hedges immediately adjacent to the existing pavilion, offer suitable habitat for forage and shelter (see fig: 9 below) as well as a connective corridor for mobile animals such as mammals, birds and amphibians. Thus there is a minimal risk that Great crested newt could be encountered during demolition; under current guidelines of good practice any ponds within five hundred metres of a proposed development should be surveyed.

Fig: 9 Small pond located within the corner of the adjacent field, note good connective habitats radiating away from the pond.

5:2 The presence of several ponds within five hundred metres of the proposed development works, adjacent to excellent terrestrial habitat does raise a slim possibility that Great crested newt could be encountered during works; as such, Great crested newt surveys are recommended as a precautionary measure; if Great crested newt are shown to be present, then it should be fairly simple to exercise avoidance mitigation measures to ensure no disturbance to this species thus eliminating any likelihood of an offence being committed.

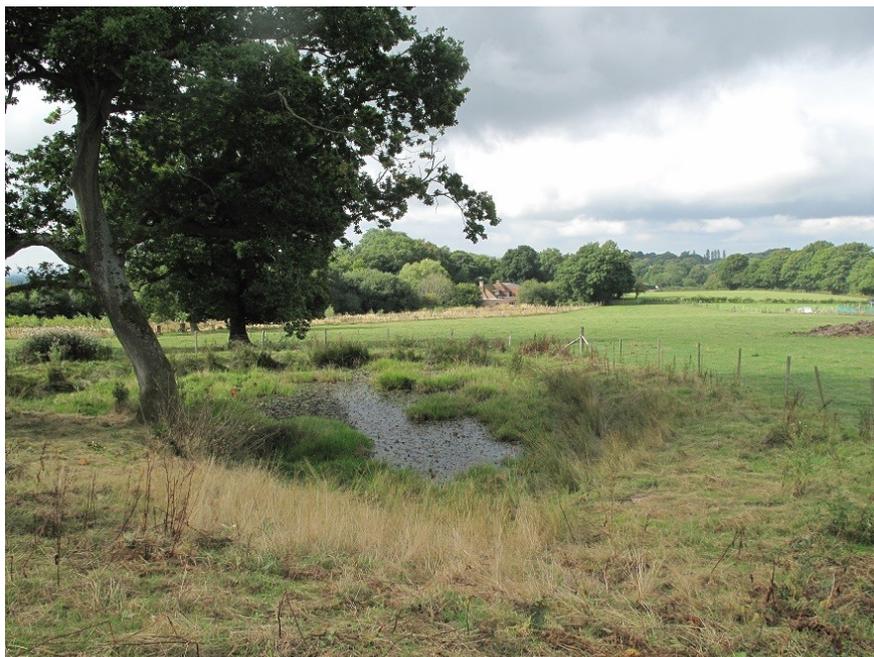
A second pond (see fig 10 below) was located further away in an adjacent field, this one is still likely to be within five hundred metres of the proposed works

Fig 10 The second pond located a little further west.
